# **Stress Corrosion Behavior of Selected Types of Stainless Steels and Titanium Alloys in a Marine Environment**

Twelve Year Progress Report

Prepared for  
**Naval Air Systems Command**  
**Department of the Navy**  
**Washington, D. C. 20360**

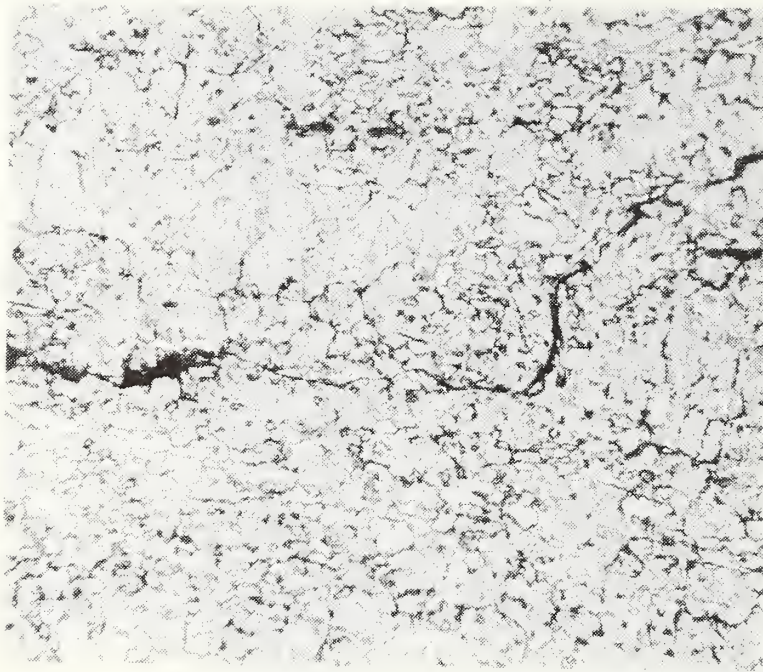
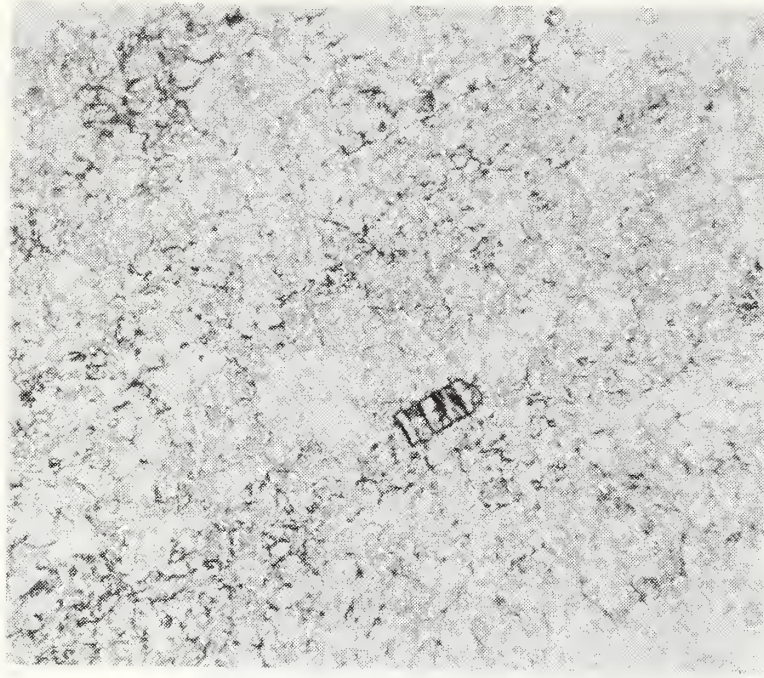
Figure 6 Microstructures of 17-7 PH alloy steel specimens.

- (a) 17-7 PH in the RH 950 condition. Crack shown is both intergranular and transgranular. Note ferrite phase. Etched, HF-HNO<sub>3</sub>.x500.
- (b) 17-7 PH in the RH 1075 condition. Note that for this alloy as the tempering temperature is increased from 950° F (as in 6a) to 1075° F that the ferrite phase reverts to austenite. Etched, HF-HNO<sub>3</sub>.x500.

17-7 PH in the RH 950 condition also revealed a mixed mode of fracture as seen in Figure 6a. The ferrite phase is visible in this micrograph. As the tempering temperature is increased to 1075°F this phase is no longer visible as shown in Figure 6b. The ferrite reverts to austenite as the tempering temperature is raised above 1050°F<sup>(10)</sup>. Also shown in this micrograph are cube shaped titanium nitride inclusions which were found distributed throughout the alloy.
